INDOOR AIR QUALITY ASSESSMENT

**Ipswich Department of Public Works
100 County Road
Ipswich, Massachusetts**

Prepared by:
Massachusetts Department of Public Health
Bureau of Environmental Health
Indoor Air Quality Program
January 2008

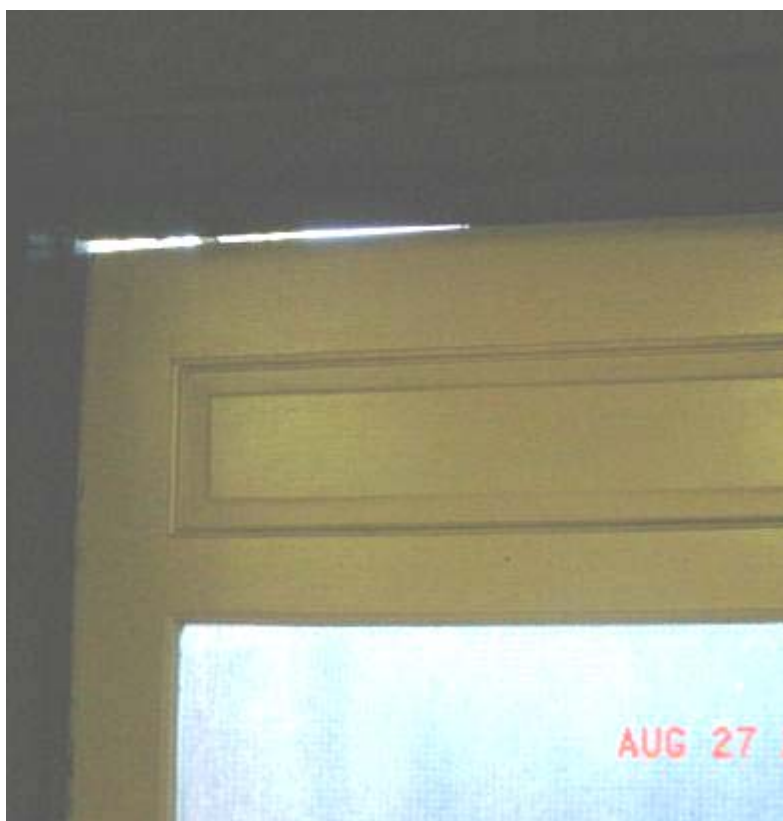
Picture 1

Large Space at Top of Closed Exterior Break Room Door

10. Repair/replace exterior door to break room to reduce drafts/moisture/pest entry.
11. Have restroom exhaust vent inspected by town electrical inspector and/or licensed electrician to ensure proper installation/operation.

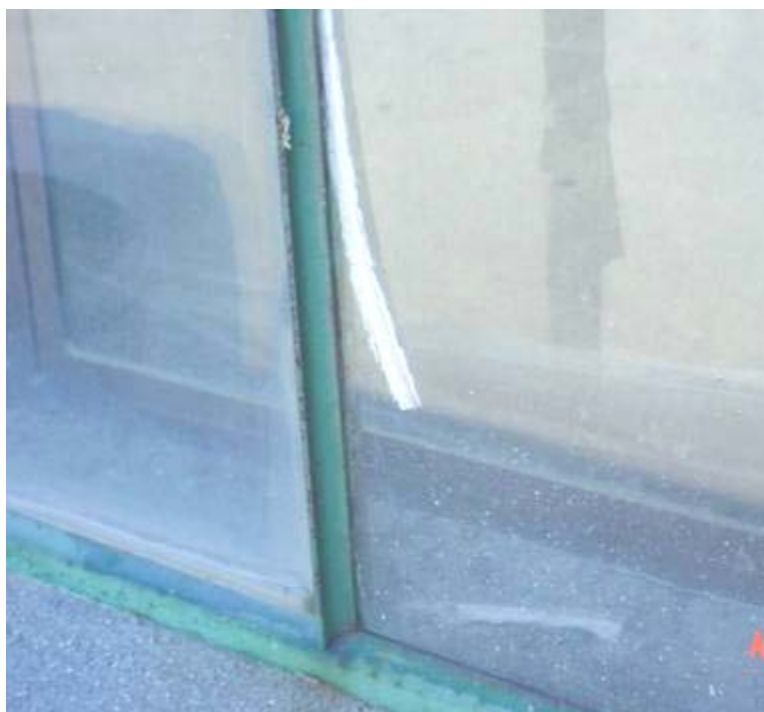
Picture 2

Missing/Damaged Window Caulking

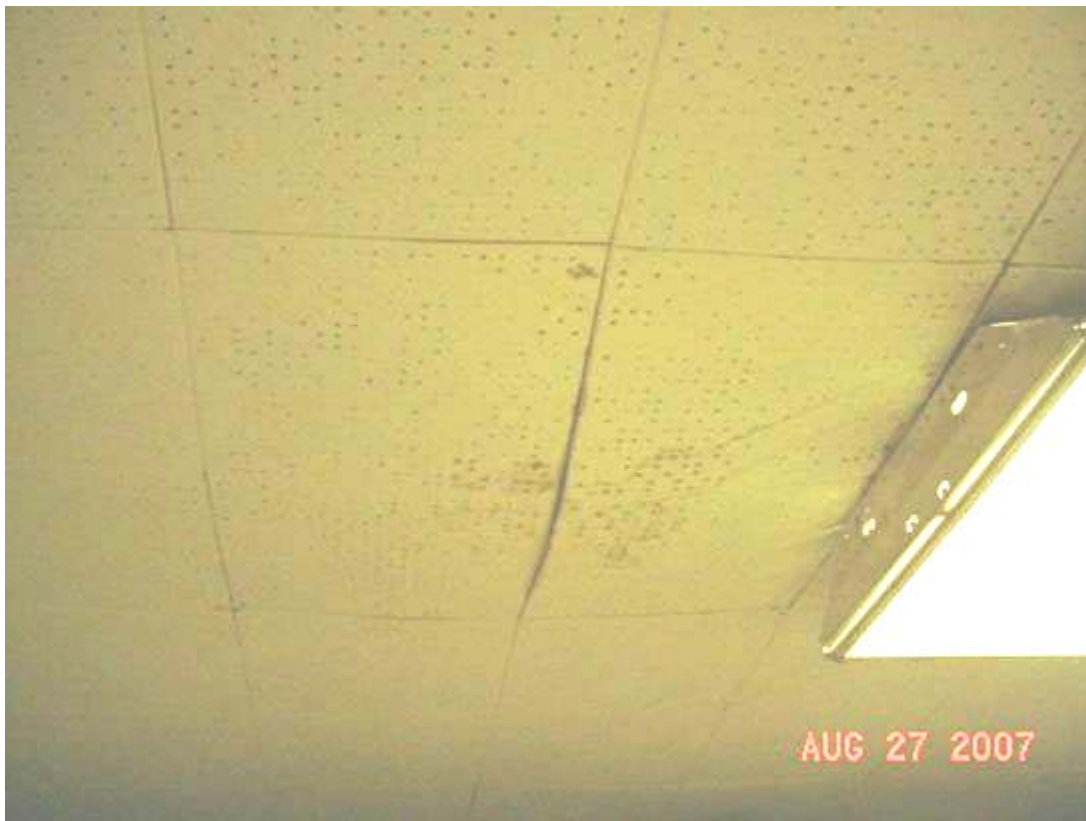
Picture 3

A number of areas had water-stained, missing or damaged ceiling tiles (Picture 3). Occupants reported that the building has on-going roof leaks. Water-damaged ceiling tiles can provide a source for mold growth and should be replaced after a moisture source or leak is discovered and repaired.

Water Damaged/Bulging Ceiling Tiles in Break Room

12. Make temporary roof repairs to eliminate current leaks. Once leaks are repaired replace water damaged ceiling tiles.
13. Replace all covers for florescent light fixtures.

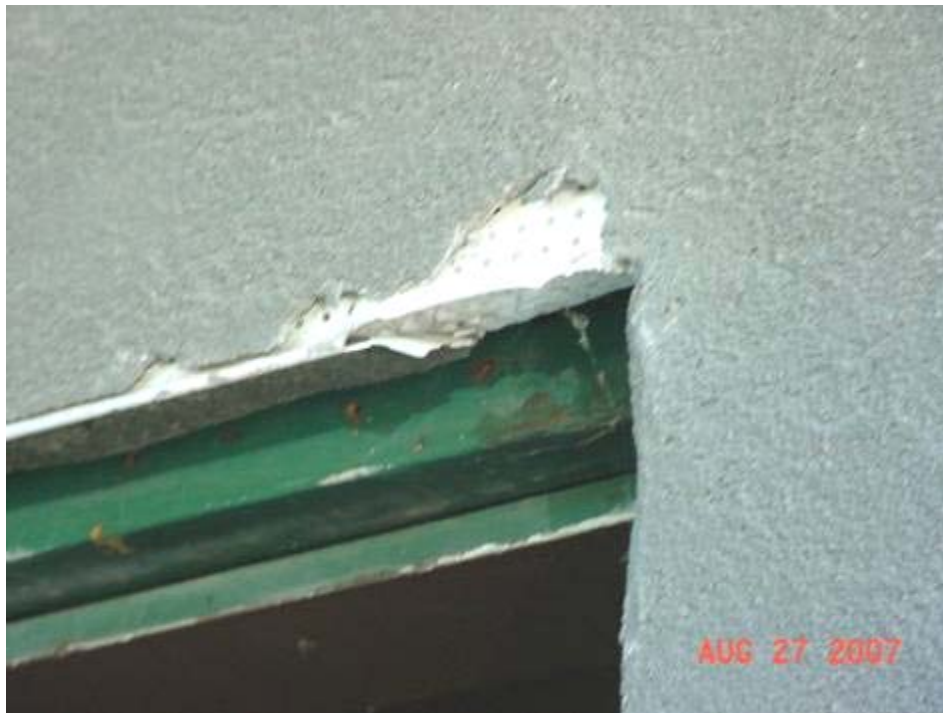
Picture 4

Breaches in the building envelope were observed in a number of areas around the building (Pictures 4 through 6), which can undermine the integrity of the building envelope and provide a means of water entry by capillary action into the building through the exterior wall system. The US Environmental Protection Agency (US EPA) and the American Conference of Governmental Industrial Hygienists (ACGIH) recommend that porous materials be dried with fans and heating within 24 to 48 hours of becoming wet (US EPA, 2001; ACGIH, 1989). If porous materials are not dried within this time frame, mold growth may occur.

Damaged Building Exterior

14. Make repairs to building exterior to prevent water/draft/pest intrusion.
15. Install carbon monoxide detectors in the garage and one in the occupied area (where occupants spend the bulk of their time).

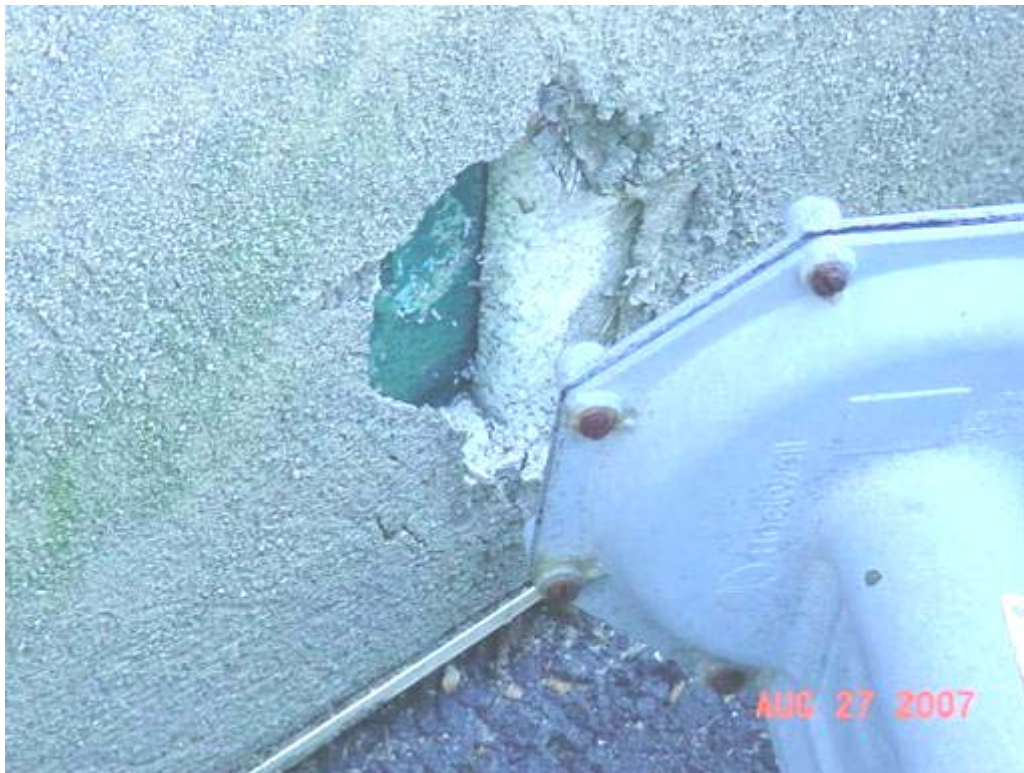
Picture 5

Damaged Building Exterior, Exposing Insulation Material

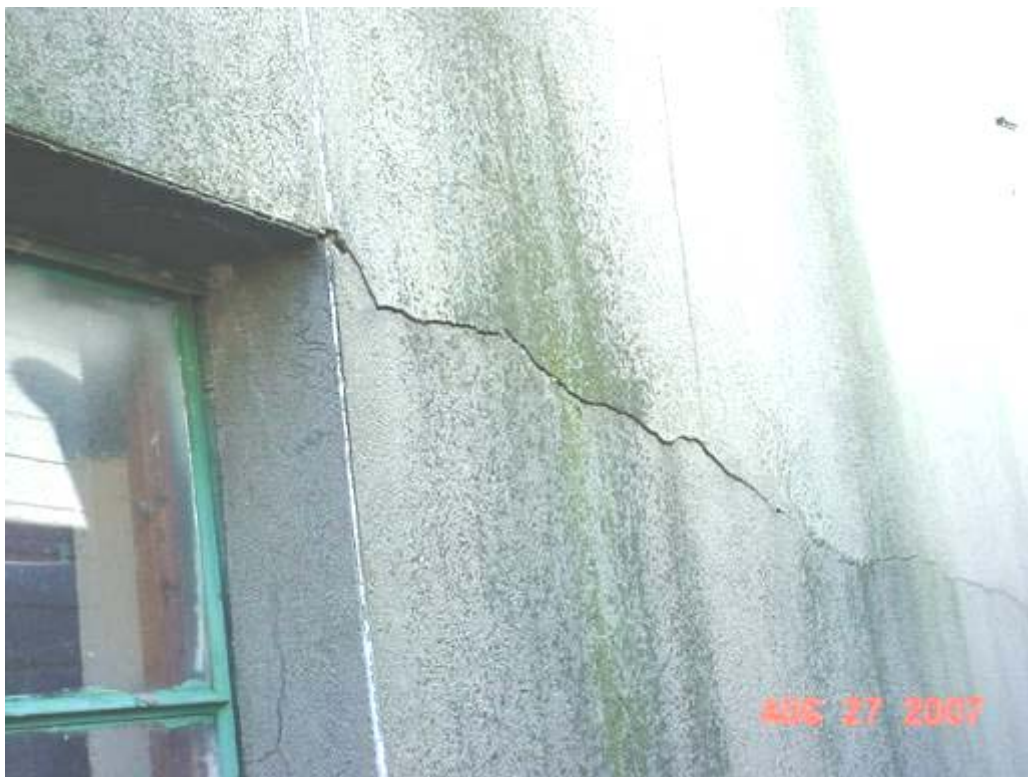
Picture 6

Damaged Building Exterior

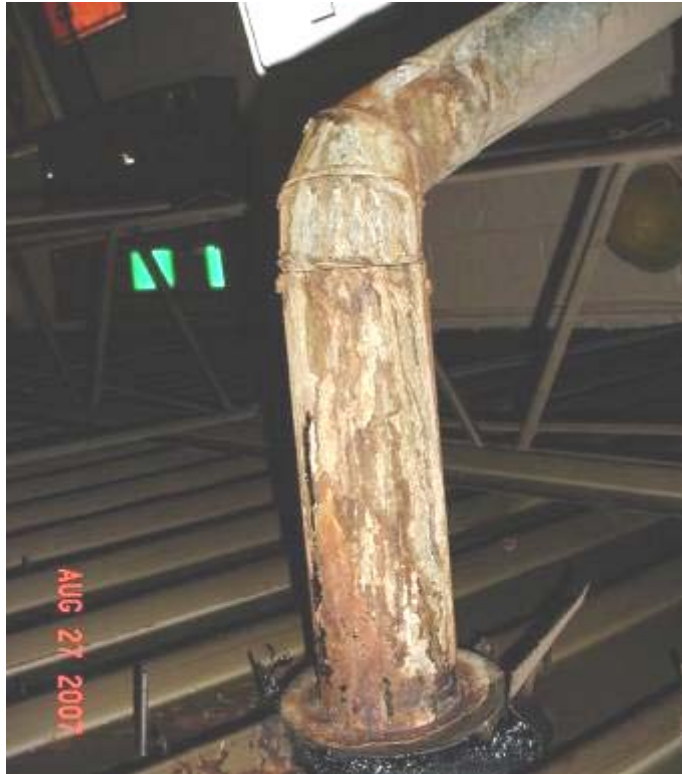
Picture 7

Another source of carbon monoxide and particulates was a gas-fired hot water heater located in the loft. BEH staff examined the water heater and found that the exhaust duct was corroded/damaged and was not centered above the exhaust flue, which could provide a means for pollutants to migrate into adjacent areas (Pictures 7 through 9).

Corroded Water Heater Vent Pipe

3. Have water heater inspected to ensure proper installation/operation. Make repairs to exhaust ductwork to prevent the escape of exhaust emissions into the building.

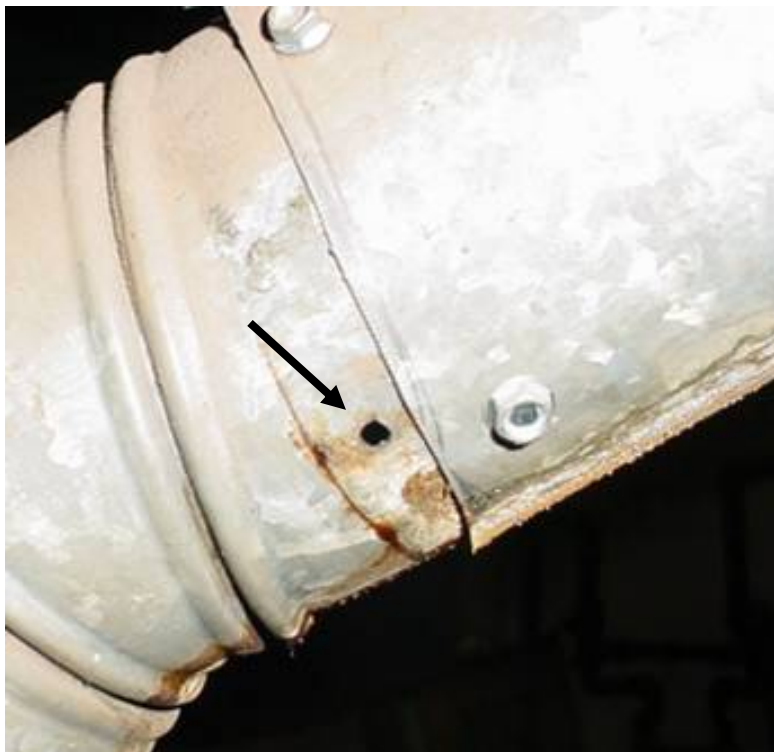
Picture 8

Hole in Water Heater Exhaust Vent Duct

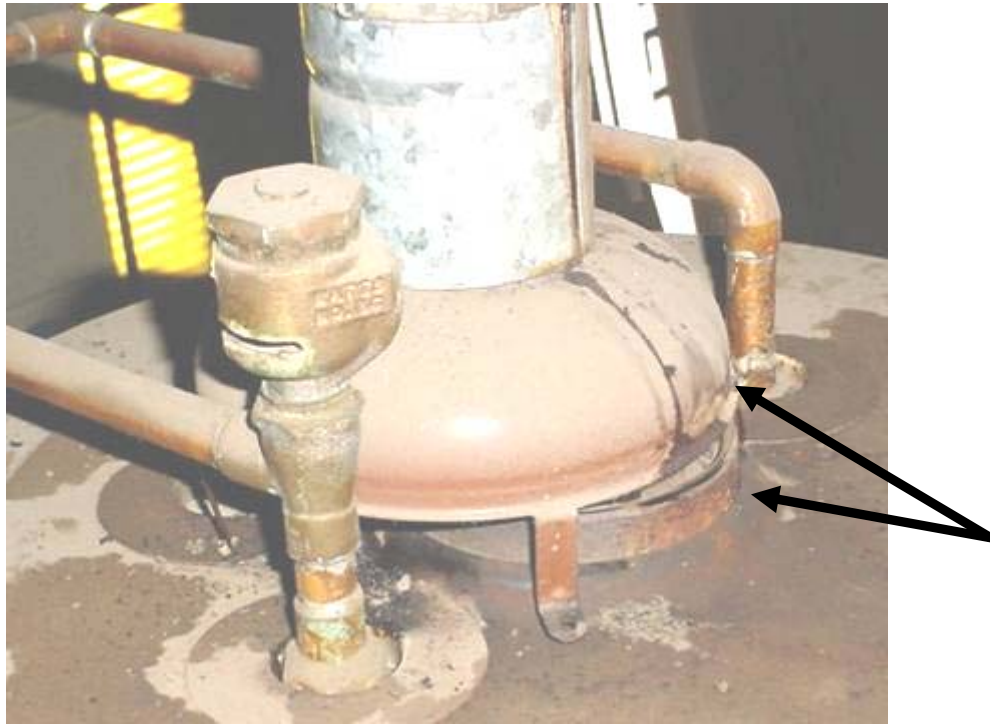
Picture 9

Water Heater Exhaust Duct, Note Duct is not Centered over Exhaust Flue

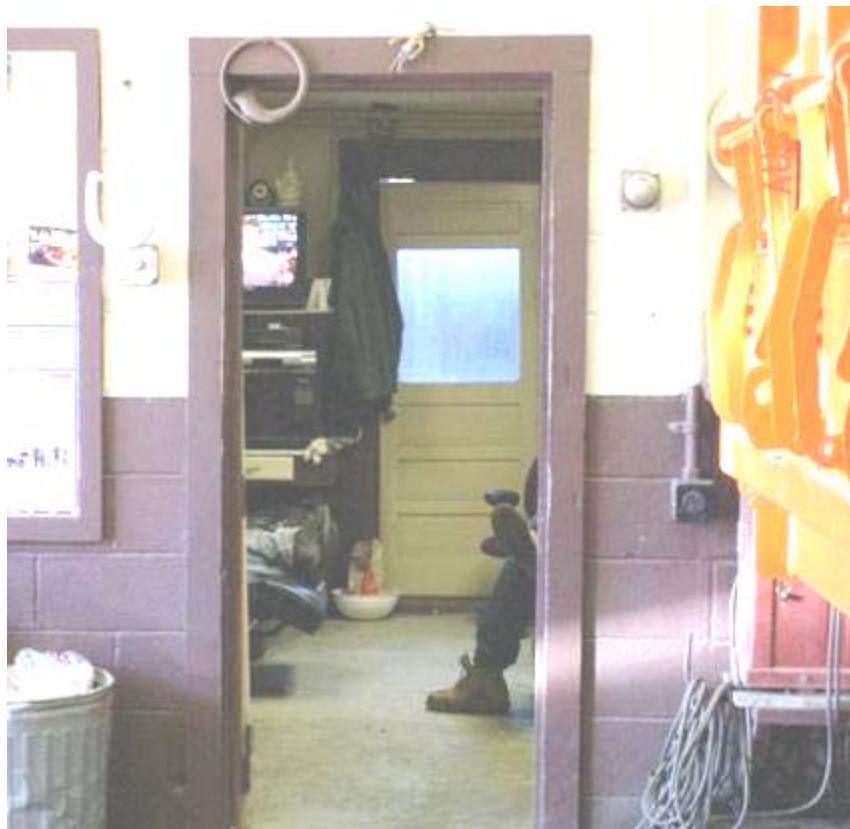
Picture 10

into occupied areas were identified. The doors to the office and break room were open and/or were damaged (Pictures 10 through 12). In addition, the glass to the office window was missing, allowing free flow of air between the office and garage (Picture 12). Each of these breaches presents a pathway for airborne pollutants to move from the garage into adjacent areas. In order to explain how these pollutants may be impacting adjacent areas, the following concepts concerning heated air and creation of air movement must be understood.

Door to Break Room Held Open

6. Keep all doors accessing the garage closed at all times.
7. Ensure doors with access to the garage fit completely flush with their threshold, replace if necessary. Seal doors on all sides with foam tape, and/or weather-stripping. Ensure tightness of doors by monitoring for light penetration and drafts around doorframes.

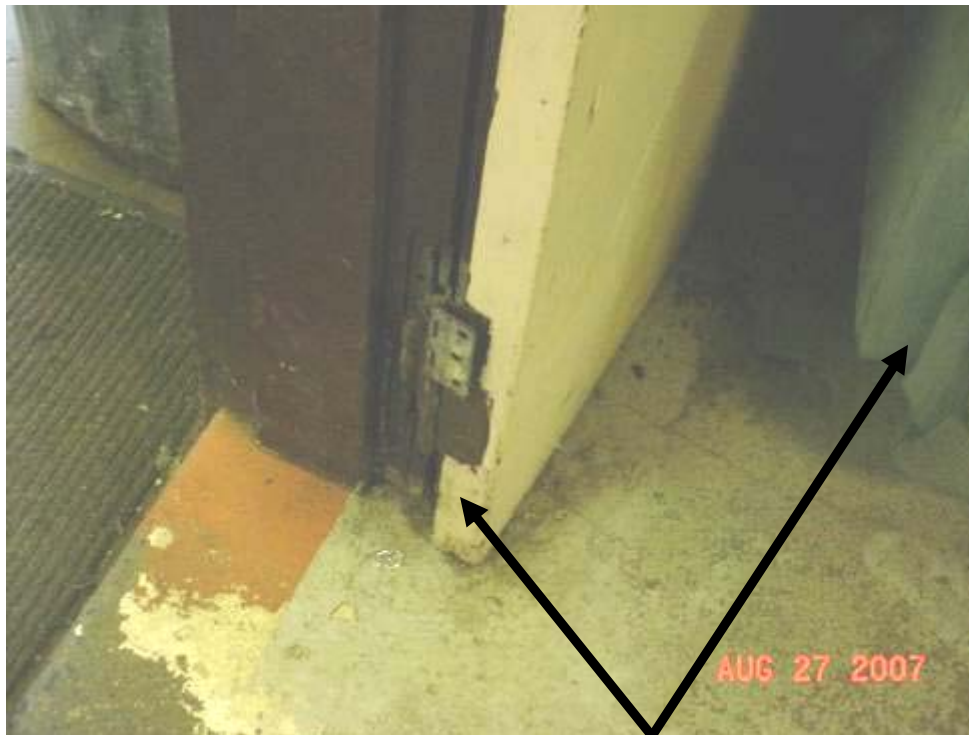
Picture 11

Damaged Door Hinge to Break Room, Note Door Held Open by Chair

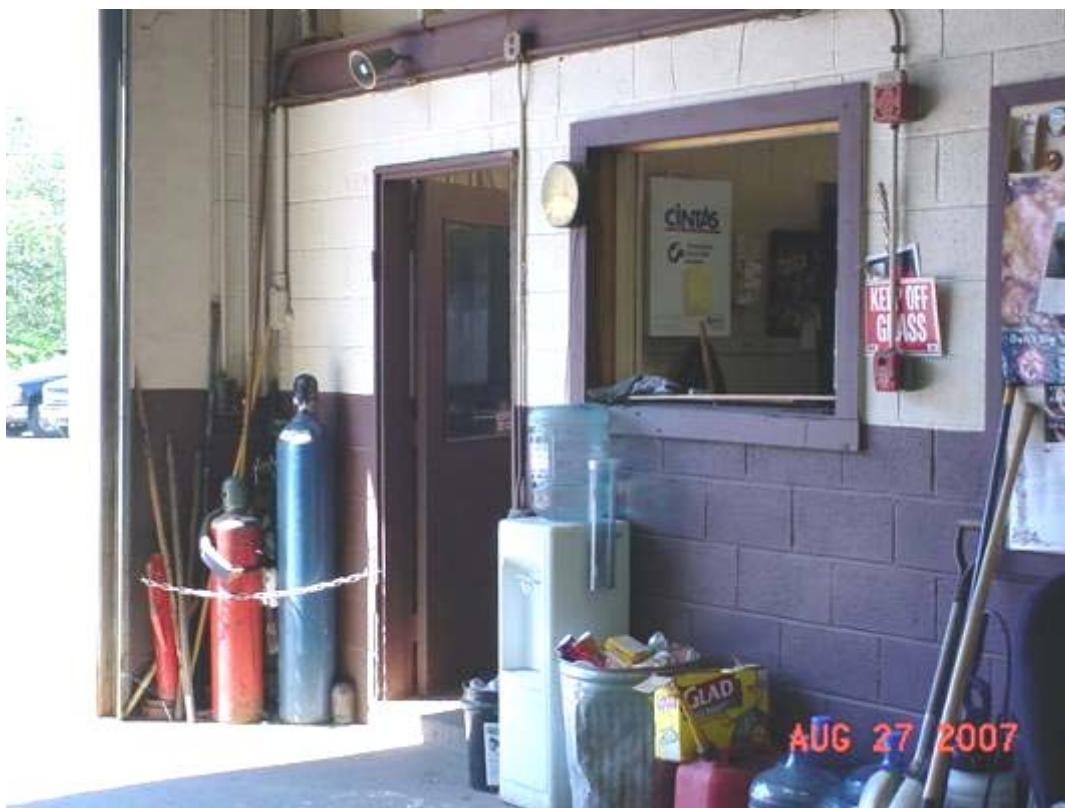
Picture 12

Missing Window and Door to Office Open to the Garage

8. Install window for DPW office.
9. Identify and seal any utility holes that traverse the common wall between the garage and mechanics' bay and their terminus to reduce/eliminate pollutant paths of migration.

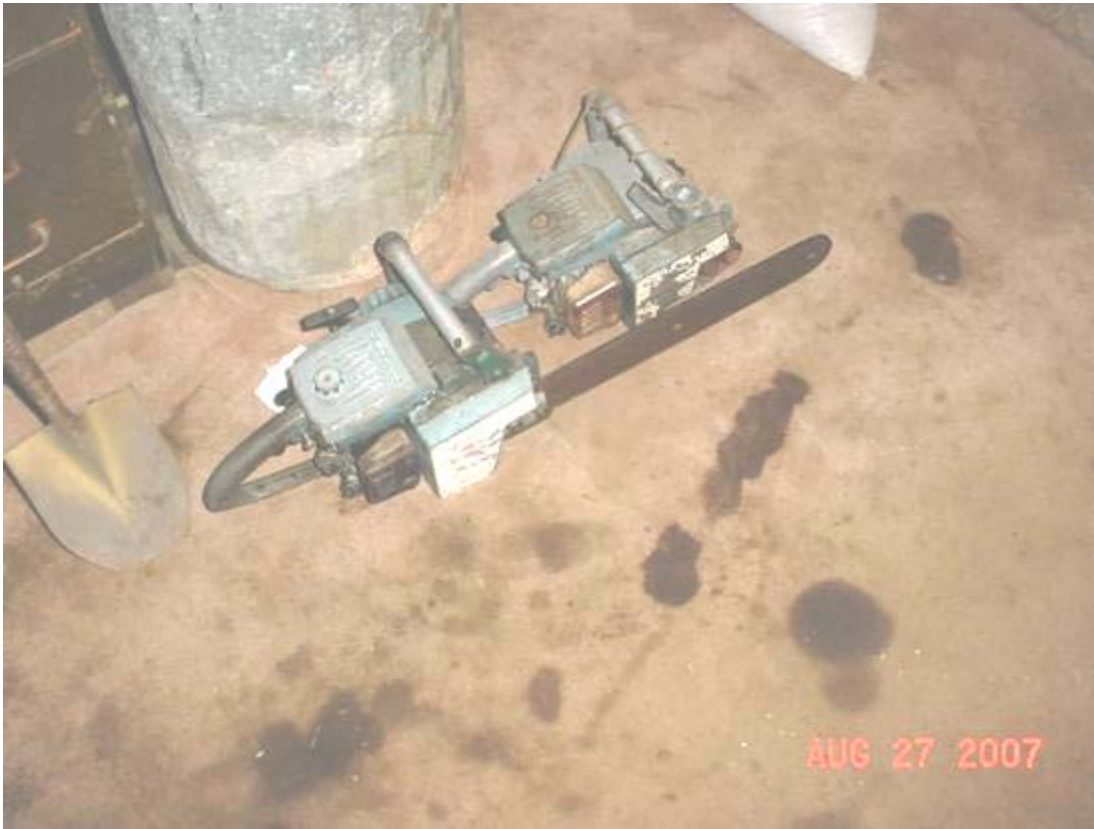
Picture 13

DPW staff also reported odors in the forestry office on the second floor (where the spill had reportedly occurred). However, it appeared that the odor was more likely related to activities conducted in the room such as small engine repair and other mechanical equipment. The room contained a number of chain saws, oils, parts, and a carpet that was extremely soiled with oil/grease stains and other accumulated debris (Picture 13). In addition, the room contained no mechanical ventilation, passive vents or windows to provide a means of air exchange, which allows odors to accumulate.

Chainsaws on Soiled Carpet in Forestry Office

4. Consider installing a window or local exhaust in the forestry office if small engine work is to be conducted.
5. Remove and discard soiled carpeting in forestry office.

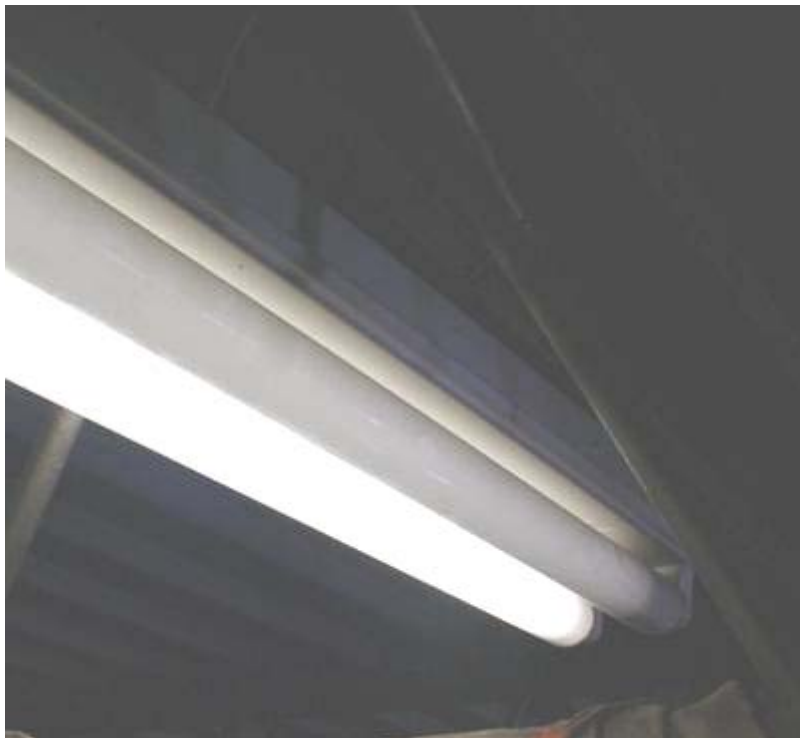
Picture 14

Throughout the building florescent light fixtures were missing covers (Pictures 14 and 15). Fixtures should be equipped with access covers installed with bulbs fully secured in their sockets. Breakage of glass can cause injuries and may release mercury and/or other hazardous compounds.

Florescent Light in Loft Missing its Cover

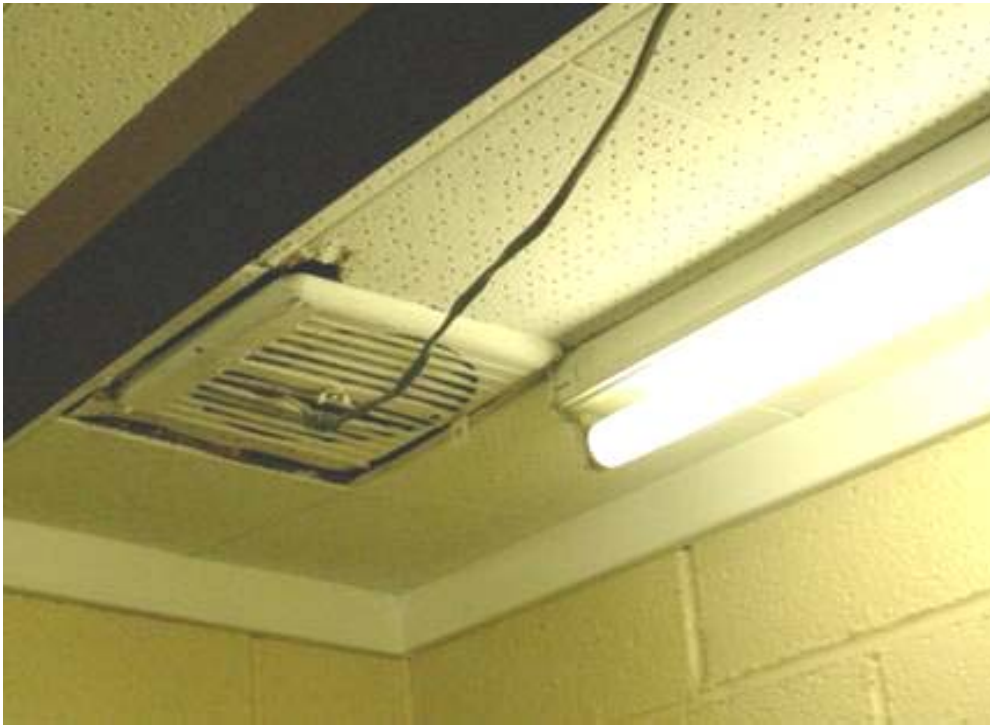
Picture 15

Finally, although the restroom is equipped with a local exhaust vent that was operable, the configuration of the vent was of concern. It is normal practice to have the electric components installed above the ceiling system. At the DPW the electric components were fed through the vent into the occupied area of the restroom (Picture 15).

Restroom Exhaust Vent, Note Electric Cord and Florescent Light Missing Cover

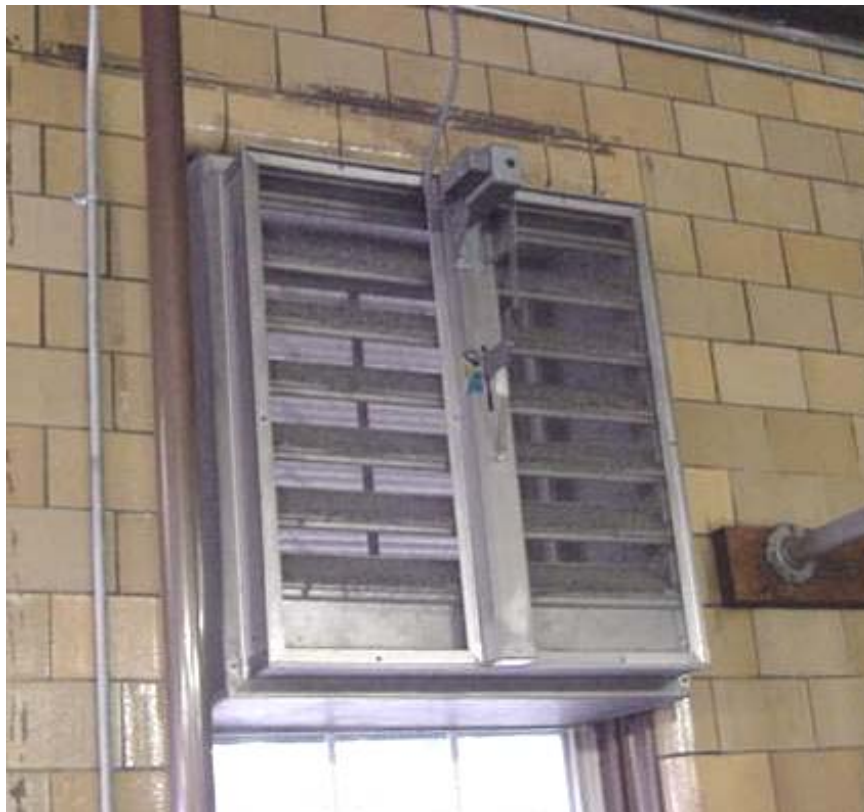
Example of Louvered Make-Up Air Vent

1. Contact an HVAC engineering to design and install local exhaust fan(s) in the garage to remove exhaust emissions. Passive louvered vents (see Picture 16 for an example) should be installed, preferable on an opposite wall to provide makeup air.
